Defect Detection in PV Arrays Using Image Processing

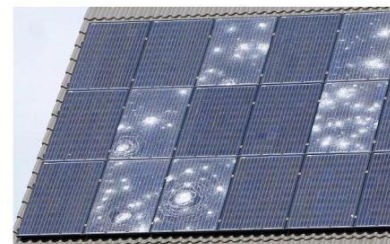
Fig. 8. Input Example Image of PV Panels with Hail Damage, cropped from the image in [14]

The following images, Figs. 8-16, resulted from applying the Steps 1-9 in *Section II - B*. Fig. 8 shows the original image with the damaged PV panels after cropping. This is then converted to grayscale as seen in Fig. 9.
